Ramot A.. Lahav y., and J. Bendel, " Planning Accessibility In the Old City of Jerusalem" in *Universal Design Handbook second edition*, Preiser W.F.E., and K.H.Smith (eds.) U.S.A; MaGraw Hill, 2010 chapter 16 pp.16.1-16.11

## PLANNING ACCESSIBILITY IN THE OLD CITY OF JERUSALEM

Avi Ramot, Yael Danieli-Lahav, Judith Bendel

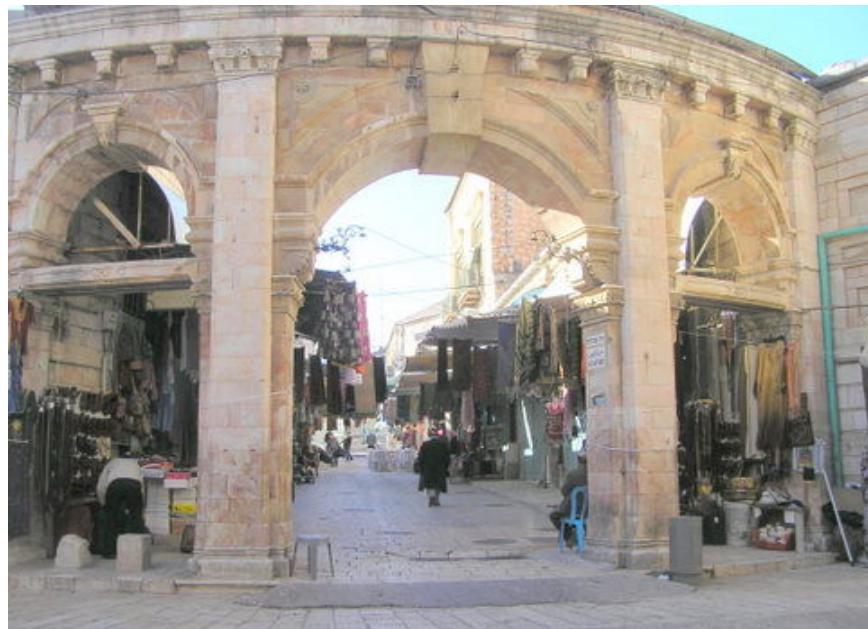
**Figure 16.1.** Muristan square, located next to the church of the Holy Sepulcher. The accessible gate to the Muristan Square, a busy shopping and restaurant enclosure, where merchandise is displayed on the street outside the shops as everywhere else in the Old City.

**Long Description:** This photo shows a semicircular triple-arched gate built of masonry in a neoclassic style. The threshold is lifted from the street lime stone pavement by a 12 cm step (made to block out vehicle). The entrance was modified to accommodate wheelchair users by insertion of a concrete ramp. Beyond the gate, there is a commercial street, about 8 m wide, where a significant amount of merchandize is displayed outdoors. The shops are tourist-oriented, offering ethnic clothing hanging down from shop-marquees, baskets, and artisan work displayed on the street pavement, and local restaurants with outdoor seating.

The Old City of Jerusalem has been settled continuously for more than 3,000 years. The current structure including the Old City walls and location of its gates exist since the early medieval era (Prawer, 1972; Rubin, 1999). The Old City contains a mixture of old and new construction, archeology, history, people of many different religions, holy sites. Each of the main monotheist religions and their denominations has their own holy sites within the Old City walls. The area is characterized by very dense population, about 35,000 residents (Jerusalem Statistical Yearbook, 2005) and in addition there are about 10 million visitors per year. This chapter discusses the tools and planning processes of accessibility in the unique and complicated nature of the Old City of Jerusalem, a model for other historic cities (see Figure 16.1).

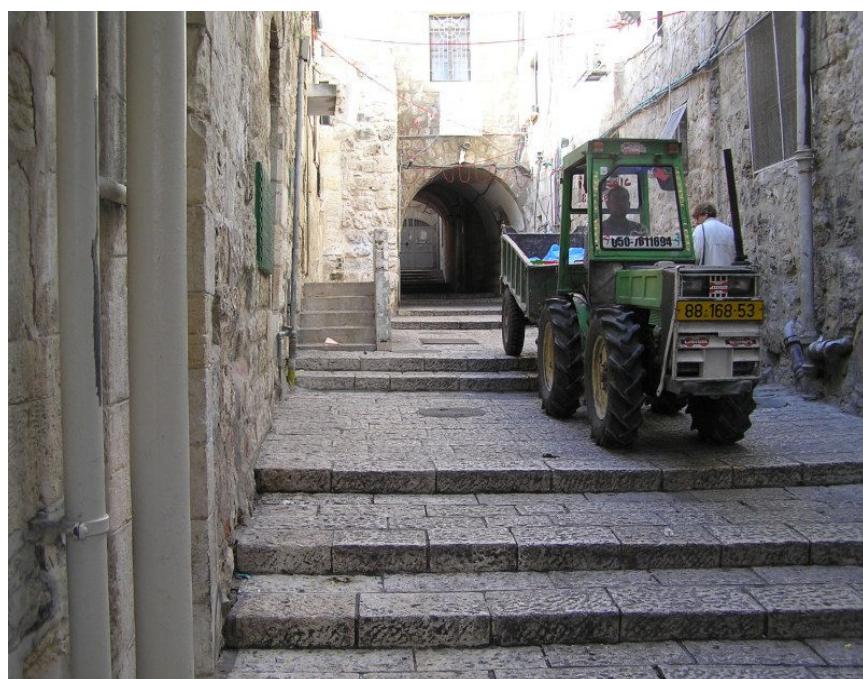
**FIGURE 16.2.** Residential stairway street in the Moslem Quarter. Narrow municipal service wagon, specially adapted for the narrow stairway streets, are an effective way to provide the Old City with routine municipal sanitation and maintenance services.

**Long Description:** This photo shows a residential stairway street climbing up the hill. Most of the rises are up to 14 cm, while the treads differ from 30 cm to 60 cm. The stairs are grouped by two to three steps, with landing of about 180 cm in-between. The average width of the street is about 3 m and is paved with lime-stone tiles. On the rear, the street is blocked by a residential building, allowing the public an arched path of 180 cm wide and 270 cm high. The photo shows a narrow (100 cm or less) municipal service wagon which is pulled by a modified small tractor, driving on the stairway with a man passing by the side of the vehicle.

- The most common is for pedestrians who can use all streets, as long as their physical fitness permits them to use the stairs (see Figure 16.2).
- Carts and cars, built specially to suit the crowded streets, are used for transporting merchandise. For that purpose, narrow stone ramps were added to enable pushing them. These ramps are fitted to meet the distance between cart wheels (see Figure 16.3).

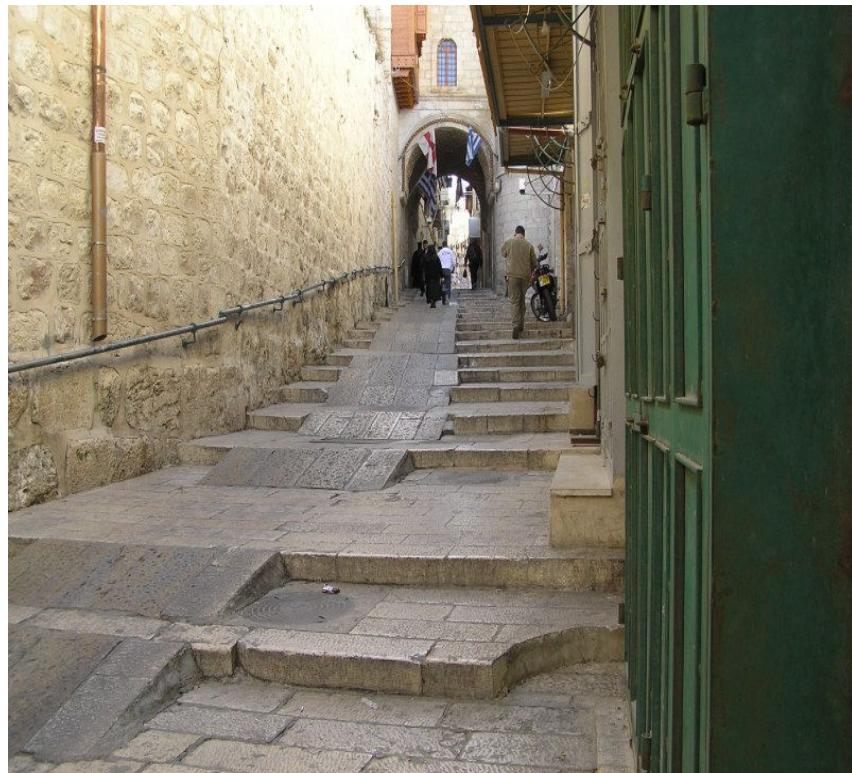
**Figure 16.3.** Semi commercial street, Christian Quarter. A Street constructed as a stairway is paved by limestone tiles with a handrail mounted on the left façade wall. Narrow stone ramps are anchored into the stairway for scooter and wheelchair users as well as pushers of carts and wagons.

**Long Description:** This photo shows a street that is approximately three m wide, with shops on the right hand and a continuous stone wall on the left. Typical to the Old City of Jerusalem, the street is paved with limestone tiles and is made as a stairway, which is constructed of wide treads (60 to 100 cm) with short rises (10 to 14 cm). Larger treads allow entrances to shops. Steep and narrow stone ramps are anchored into the stairway on a line. These ramps serve wheelchair or scooter users as well as carts or wagons. A handrail fixed to the wall assists the pedestrians who prefer to use the stairway beside the ramps.

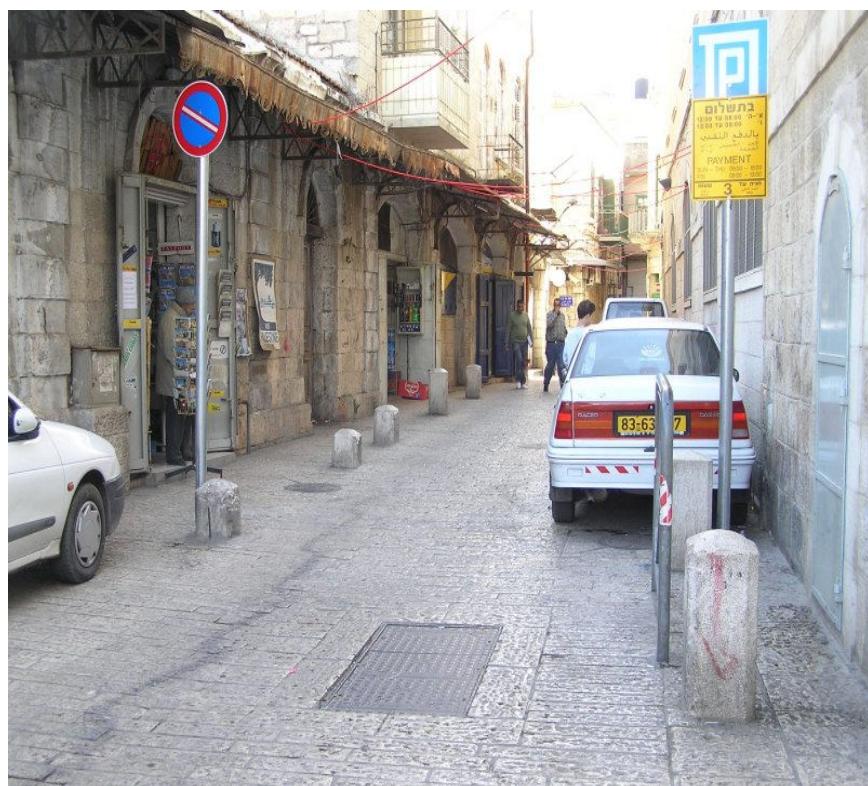
**Figure 16.4.** New Gate Streets, Christian Quarter. A street leading to the "New Gate", one of very few where private cars can enter within the walls of the Old City. Cars are parked very close to the building walls, between low stone car barriers.

**Long Description:** This photo shows a level street, about 500 cm wide, paved with lime stone tiles. The left façade is occupied by small shops, and the right façade is a mixture of buildings and a wall of a public yard. Low stone car barriers define a one way dual-purpose driving and walking route, of 320 cm wide. The distance from one barrier to the next is not constant. In front of shop entrances the barriers are grouped to block car parking, while next to blank walls the distance between the stone barriers accommodates car parking.

- Cars and narrow tractors are relatively new to the Old City. These can be used only in a limited number of streets. There is no room for a side walk in these streets, which are more or less suitable for the use of cars (see Figure 16.4).

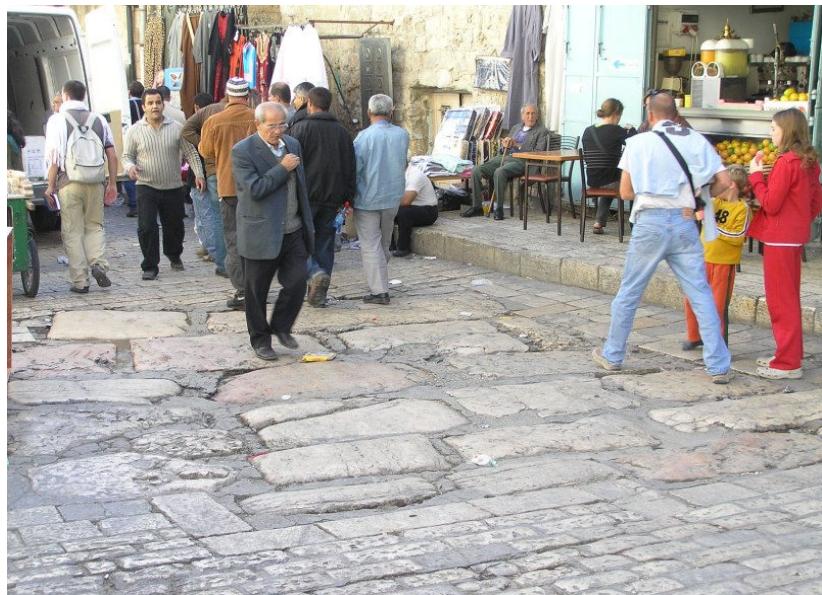
**Figure 16.5.** Via Dolorosa, with original Roman pavement in situ. A section of the Via Dolorosa is paved with original large Roman stone tiles and is combined with much smaller stone tiles of the twentieth century. Pedestrians, carts, and wagons use the pavement intensively on a daily basis.

**Long Description:** This photo shows pedestrians walking in a market street, about 300 cm wide.. The street is paved with large original Roman lime stone tiles, uneven but smooth. The impressive original Roman pavement (measured as 300/200 cm) serves as an integral part of the 20<sup>th</sup> century lime stone pavement. This section of the market street is challenging for pedestrians with mobility disabilities, who find it hard to cope with uneven surface. On the right, dresses hang for sale in front of a shop, with an open kiosk with two customers seated at an outdoor table. On the left a cart is pushed.

Once the two sets of criteria were defined, all streets and alleys of the Old City of Jerusalem were graded accordingly. A decision was taken to start work on the streets which graded at least 3 on the surface criterion (see Figure 16.5).

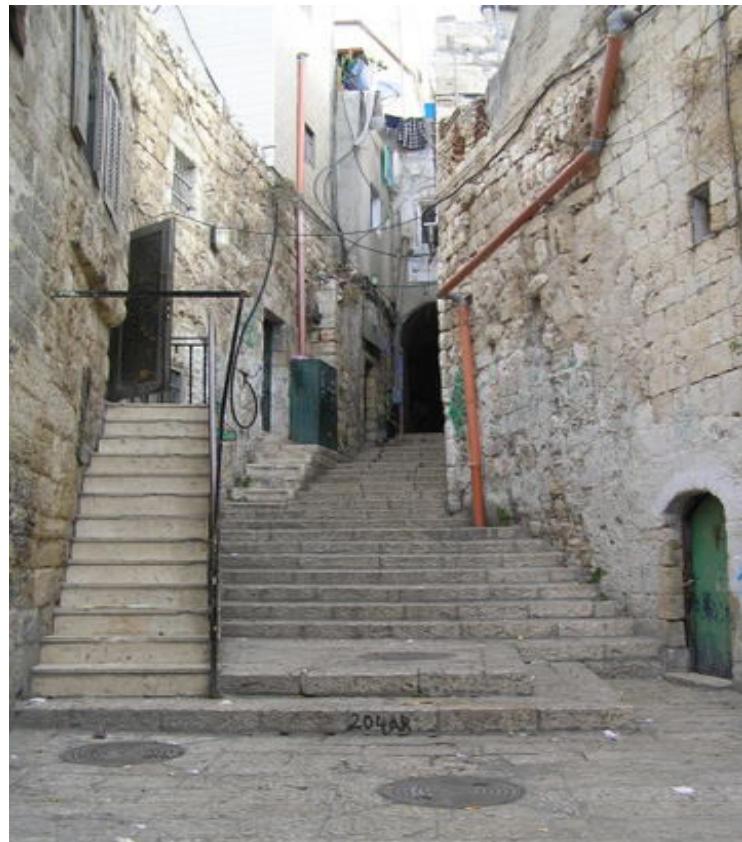
**Figure 16.6.** Semiprivate residential dead-end alley. A typical inner residential alley demonstrates different styles, sizes, angles and directions of staircases in one street, all serving private residential compounds

**Long Description:** This photo shows a dead-end residential alley, meandering up the hill. In front, the alley is evenly paved by stone tiles. From that point onward, a main wide, curved staircase leads the way. A secondary, much steeper staircase attached to the left façade, constructed of 12 steps with a handrail on one side, leads to the door of a residence. A secondary staircase of 5 steps with no handrail leads to another door in the same facade. On the right façade, a door opens to the alley. The semipublic stairway ends with an arched entrance to a private residence.

Yet, in addition to decisions based on the use of the grading system, some other components had to be considered and dealt with before any recommendations or upgrading could be implemented, such as public vs. private land ownership. The assumption is incorrect that all public areas, such as, streets alleys and squares, are public properties and everything beyond the entrance gate or door is private property in the Old City of Jerusalem. Inner dead end alleys are semi-private property, welcoming only local community members. In other cases, streets are owned by the church (see Figure 16.6).

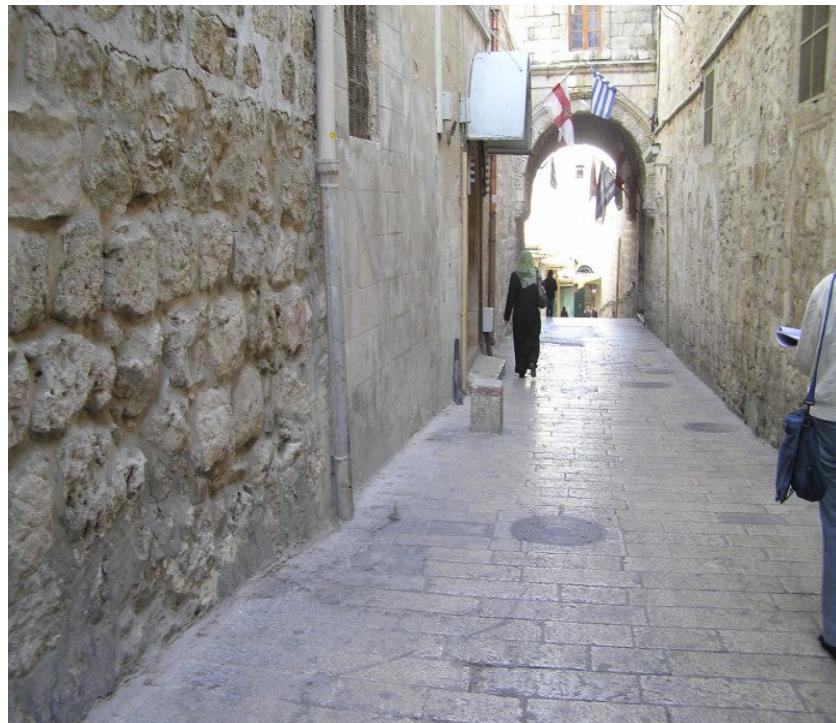
**Figure 16.7.** Renovated, noncommercial public street. One of the accessible streets transitions into a modified stair. Most accessible streets are not connected to each other in an accessible way.

**Long Description:** This photo shows a clean, recently renovated noncommercial street. In the photo the street is level, 240 cm wide, paved with limestone tiles. The left façade combines old stone walls with a newer ones, behind which is a monastery. The right stone façade belongs to a private community compound. The street is divided in two parts by a neoclassical arch. Behind the arch, the street ends with stairs going down the hill. This street is very usable, but is isolated due to the stair at the end.

The first step will be improving the existing amenities for pedestrians, in the streets within the chosen areas, which scored at least 3 on the surface item. This includes repairing stairs, adding handrails, adding signage, and providing resting places. The goal was to make a strong impact with as little disruption to residents' daily lives as possible (see Figure 16.7).
